# UCG-10 report

# Purpose of UCG10

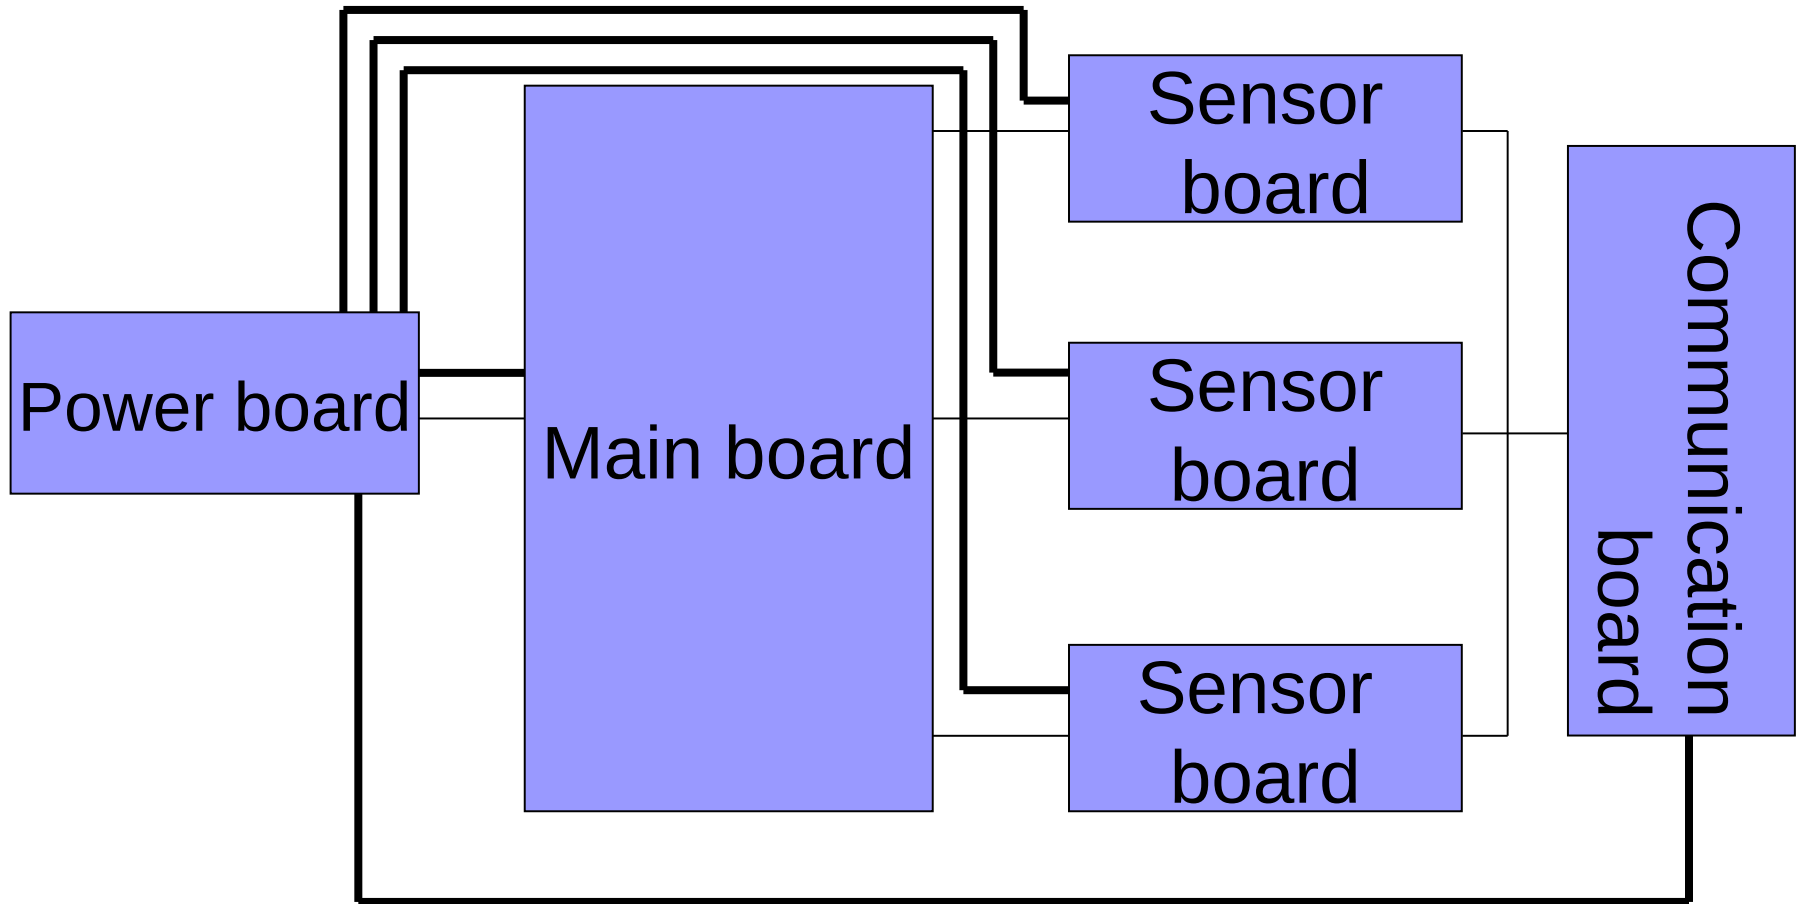
# Structure of electric circuit

We develop a new structure which use communication board.

Communication board has transmitter which sends dates to receiver placed on the ground.

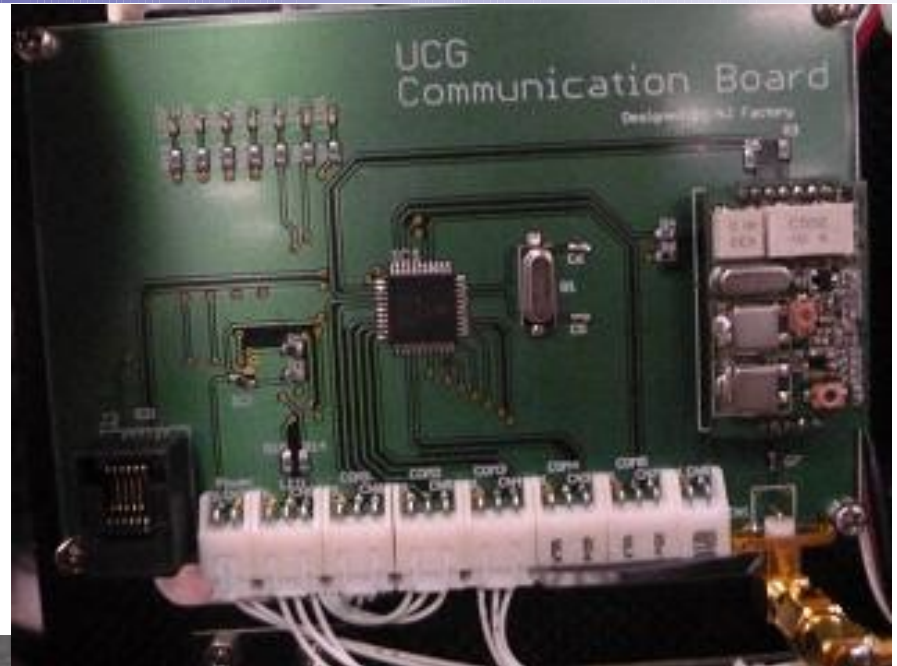
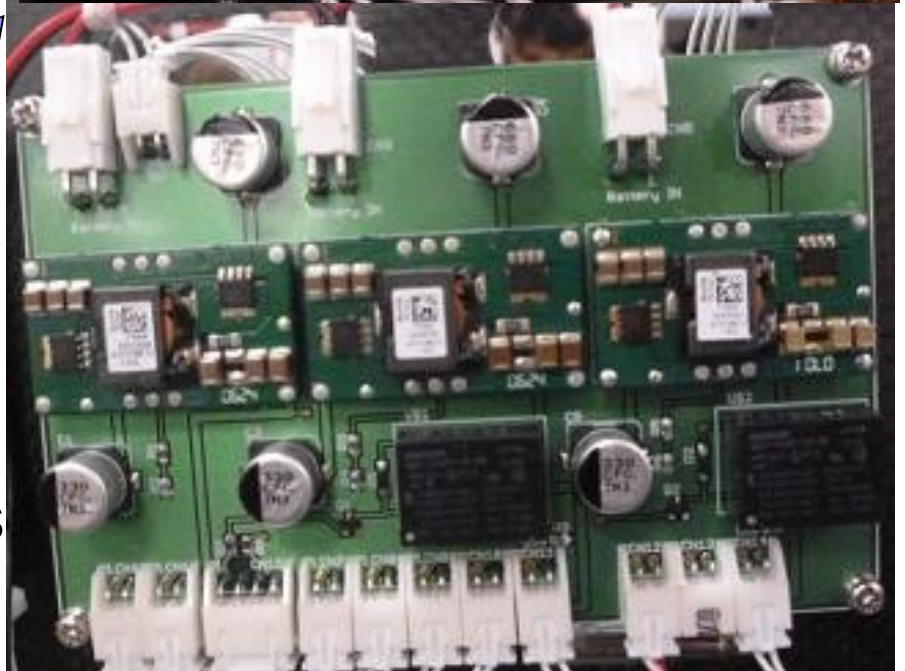
# Pictures of circuits.

Main board

Communication board

Power board

※We made three sensor boards although there is no picture.

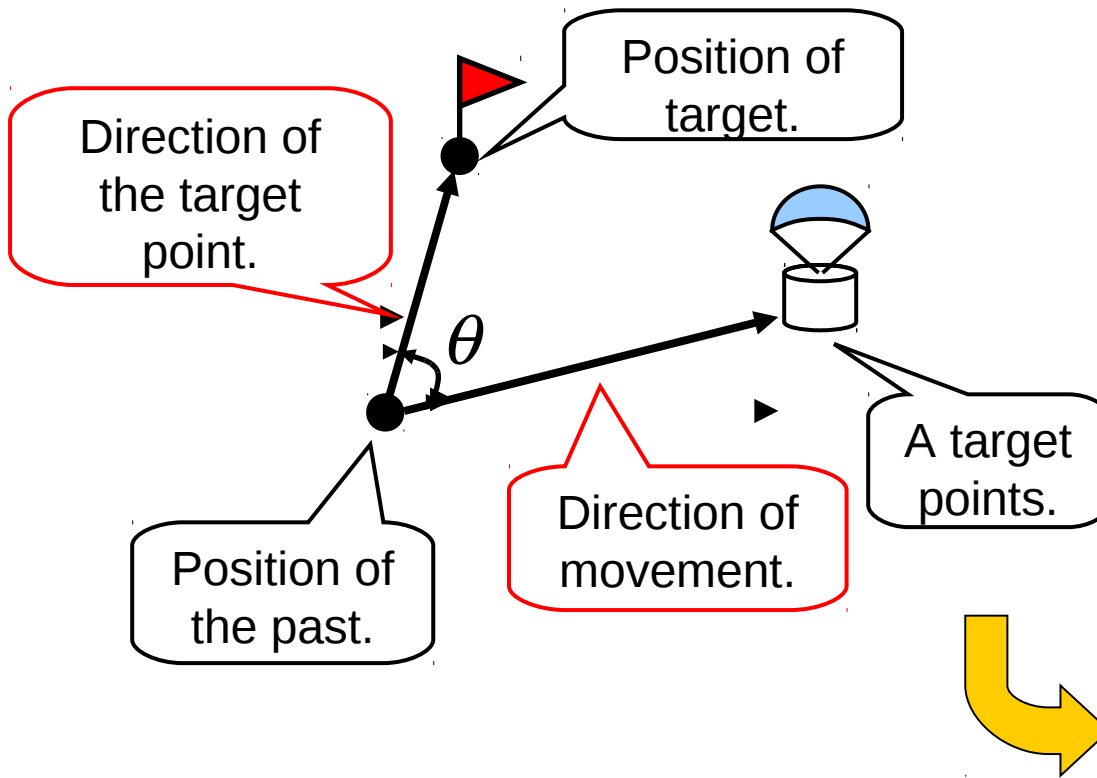
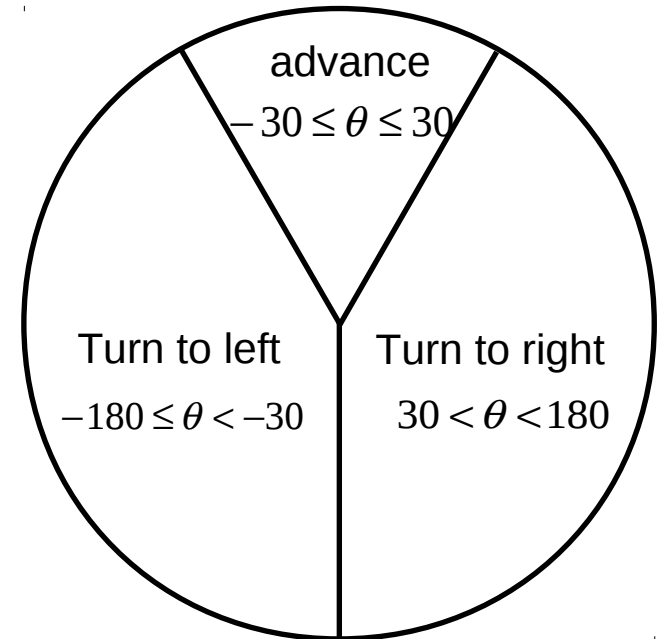
# Control of moving

It decides moving by an angle  $\theta$

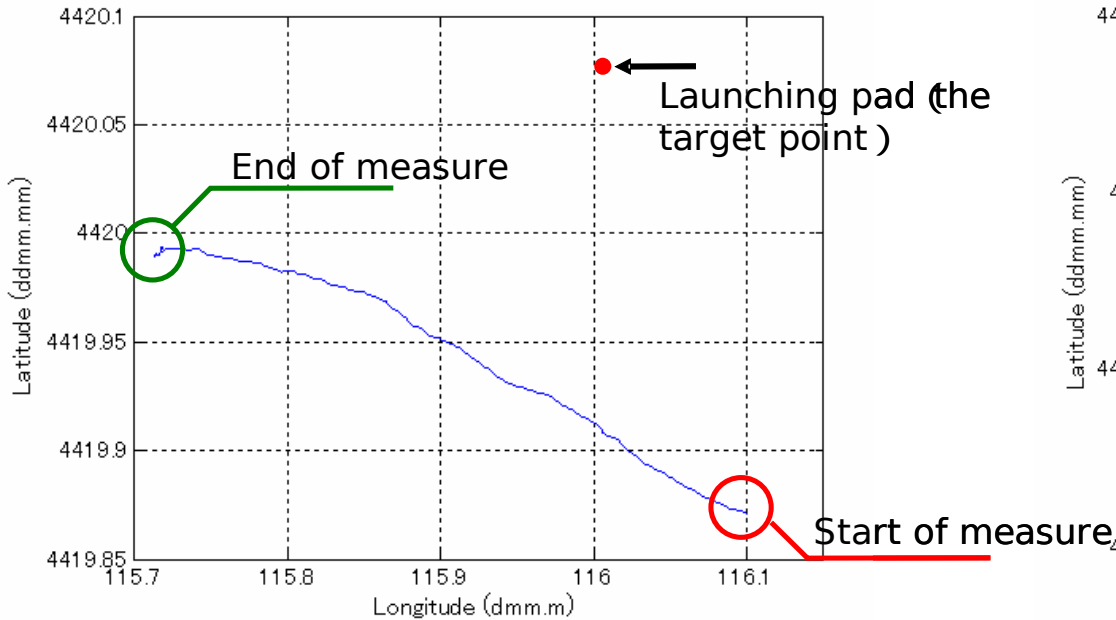
Satellite's GPS data(2 dimension)

- The rocket was recovered intact.
- The quasi-satellite could not move to the target point because of the strong winds. It is necessary to substitute a parafoil for a parachute.

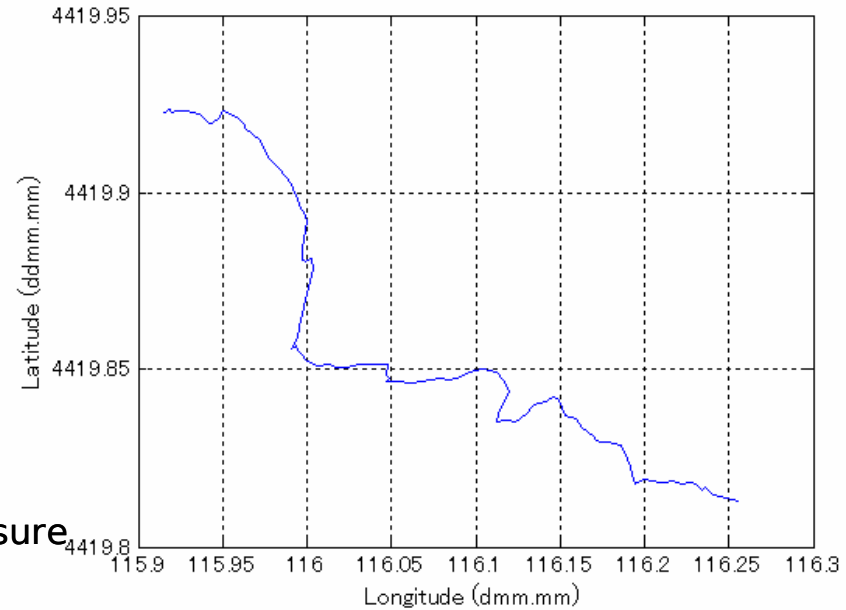
Rocket's GPS data
